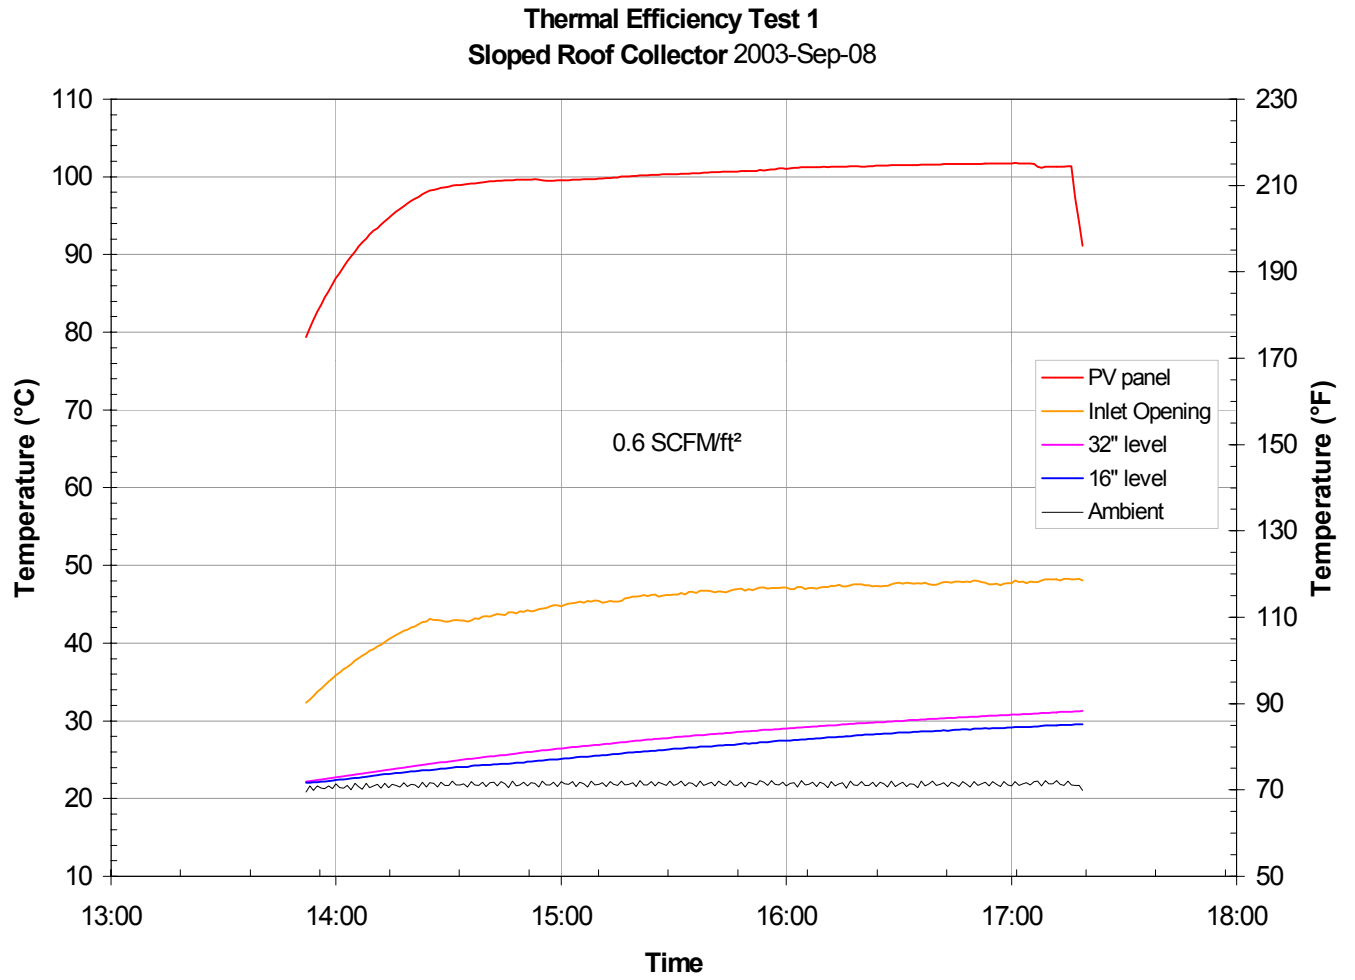
Figure 8. Air temperatures recorded during first thermal efficiency test of Sloped Roof collector.
